Jason Garber's Trip to The Gulf Coast

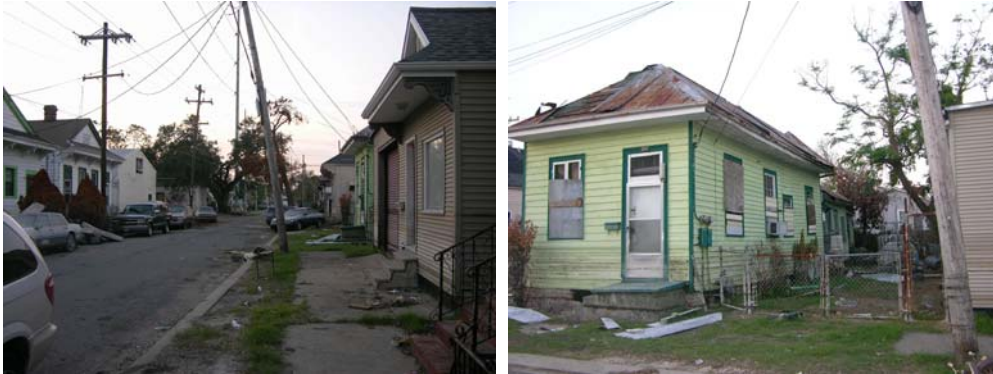
After this brief visit, Elizabeth had an appointment with a Discovery Channel crew who were documenting the recovery effort. We spent some time in a neighborhood that was “not bad”, in terms of damage. “Not bad,” meant that the houses were more or less intact, but not even close to being livable. The photo in Figure 1 does not come close to capturing the damage in this area. Standing on this street was a shock to me as it was quite simply a mess – however, compared with other areas, the damage in this area was considered to be fixable. Fixing, as with many of the houses in New Orleans, meant “gutting” the house (removing the contents, including the drywall), cleaning out the mould, and rebuilding the interior.

Figure 1 - New Orleans's neighbourhood, where the damage was "not too bad"

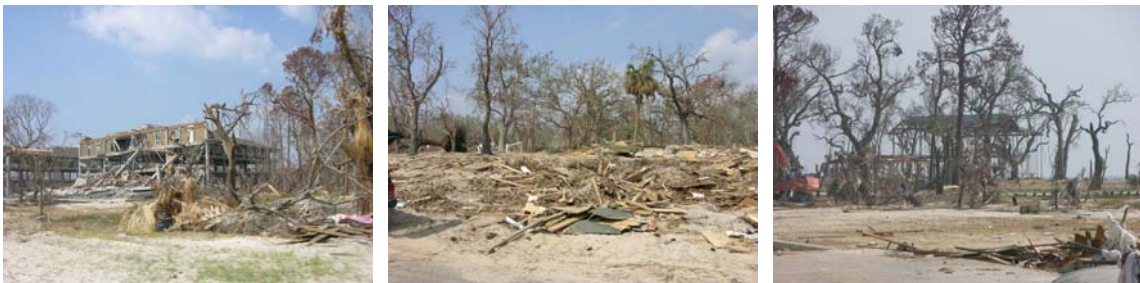
This put the “not bad” descriptor from the previous day in perspective as this area was devastated. We drove along a beachfront “scenic drive” where the view should have been of the ocean. At the moment, the “view” was of the beachfront properties which were swept clean. Whether it was wind or storm surge seemed a moot point as regardless of the specific cause, there was not much left (Figure 2).

Figure 2 - "Scenic Drive" near Pass Christian

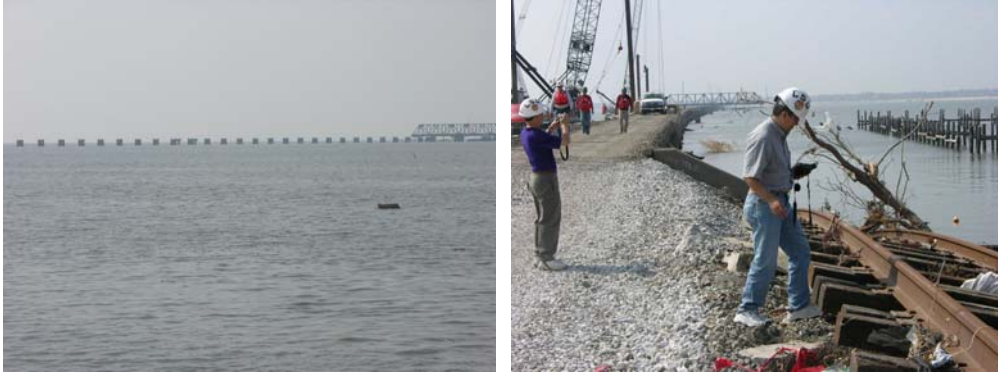
There were two bridges in this area crossing the bay – one for cars and the other for rail. The rail bridge performed much better in that all of the piers survived the storm surge, and only the entire deck had to be replaced. Construction had already begun (Figure 3).

Figure 3 - Rail bridge across Bay St. Louis (reconstruction in progress), from the East End

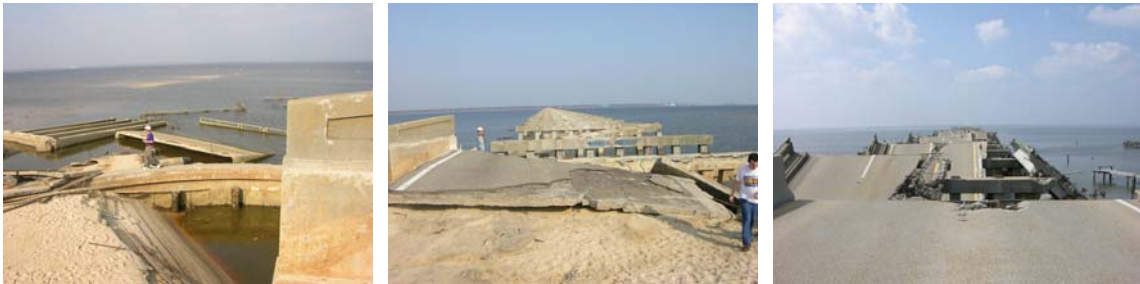
Figure 4 shows the traffic bridge from the Bay St. Louis side (west) with the piers in the center, and the roadway flipped over to the left. An obvious question would be how one can design for this type of loading (i.e., storm surge). The answer in theory seems to be to have the deck high enough to avoid the surge. However, as can be seen in Figure 3, the deck of the rail bridge was simply being replaced as is. The pressure to get the infrastructure back appeared, understandably, not to allow for time for redesign. That will come later.

Figure 4 Traffic bridge from Bay St. Louis - piers in the center, and the roadway, flipped over, to the left - the right photo is from the East end

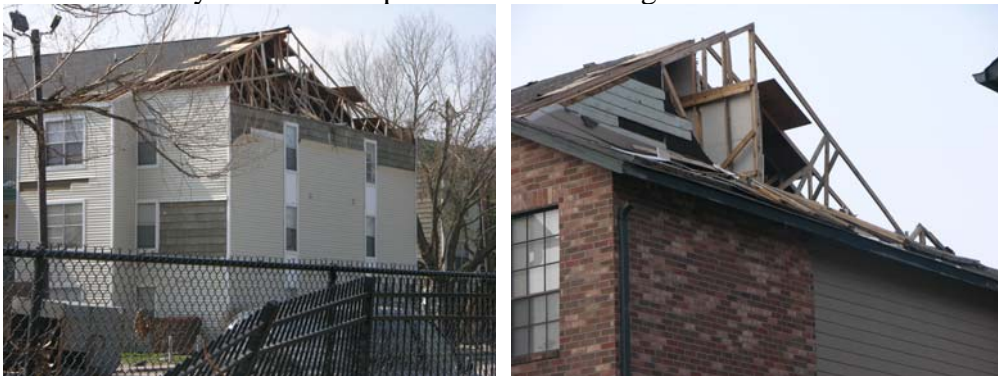
For Day 3, I was on my own and it was suggested that I try to document some textbook gable end roof failures that Marc Levitan (director of the hurricane center) had observed north of the city. Some examples are shown in Figure 5.

Figure 5 - Gable end roof failures in neighborhoods north of New Orleans

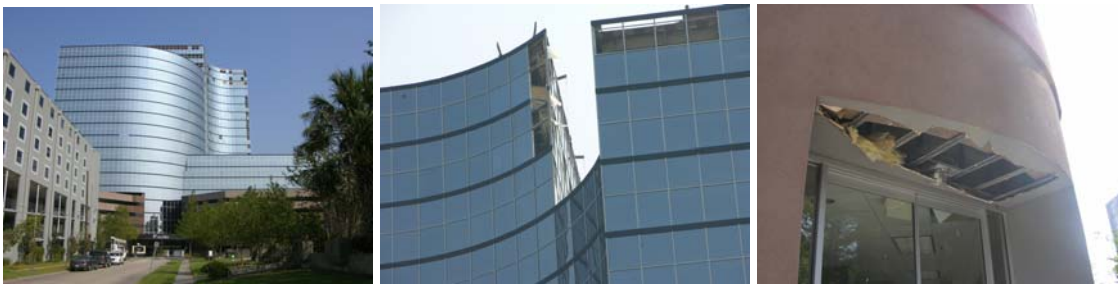
On the way back through New Orleans, I saw a high-rise office tower, which looked to have extensive damage from wind pressure as well as wind-borne debris (Figure 6). It was reassuring to note that much of the damage to the glazing was in areas where we tend to concentrate our pressure taps, although I doubt that this building would have been wind tunnel tested.

Figure 6 - Cladding damage to the Galleria building at the north end of New Orleans

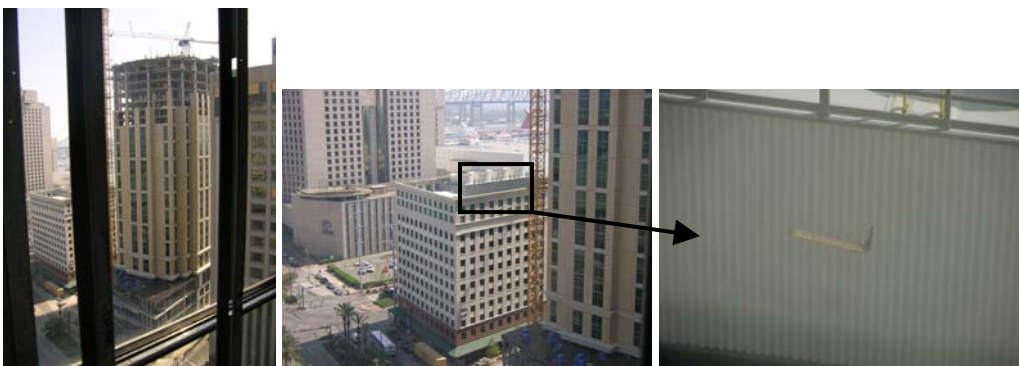
My final day was spent back in downtown New Orleans, with Elizabeth. We began with a bird's eye view from the 23rd floor of the Harrah's Hotel (the hotel that RWDI tested, which was under construction), thanks to Bhavna Mistry. As noted earlier, the damage to Harrah's was minimal (and long since cleaned up), although a notable exception was a textbook case of impact from flying debris, shown in Figure 7.

Figure 7 - View of Harrah's from the W Hotel, with 2 x 4 Lodged in Wall

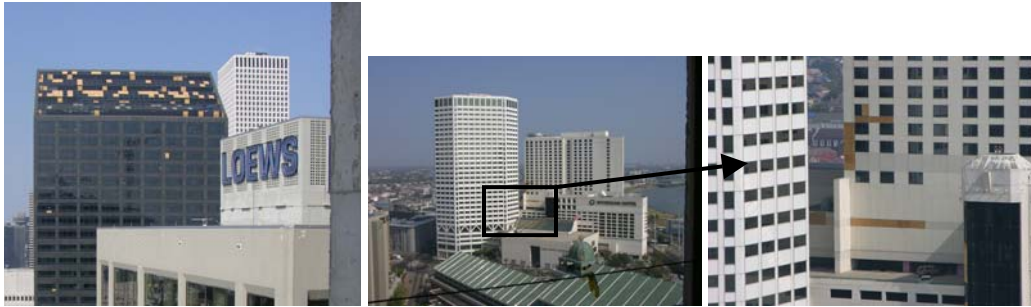
Looking in all directions from Harrah's, there was damage of varying degrees to numerous high-rise towers, as seen in Figure 8.

Figure 8 - Views from Harrah's

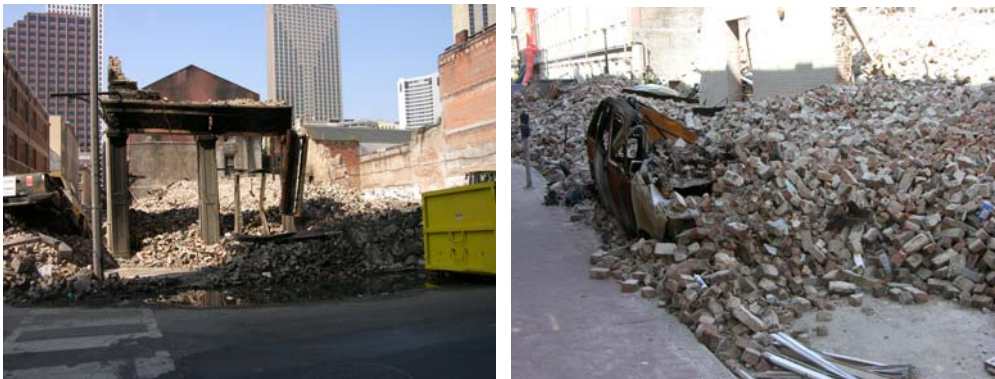
From street level, one notable failure was the total collapse of a brick building (Figure 9) – it wasn't apparent at first if this was hurricane damage or deliberate demolition. The demolished cars among the rubble seemed to answer that question.

Figure 9 - Demolished brick building

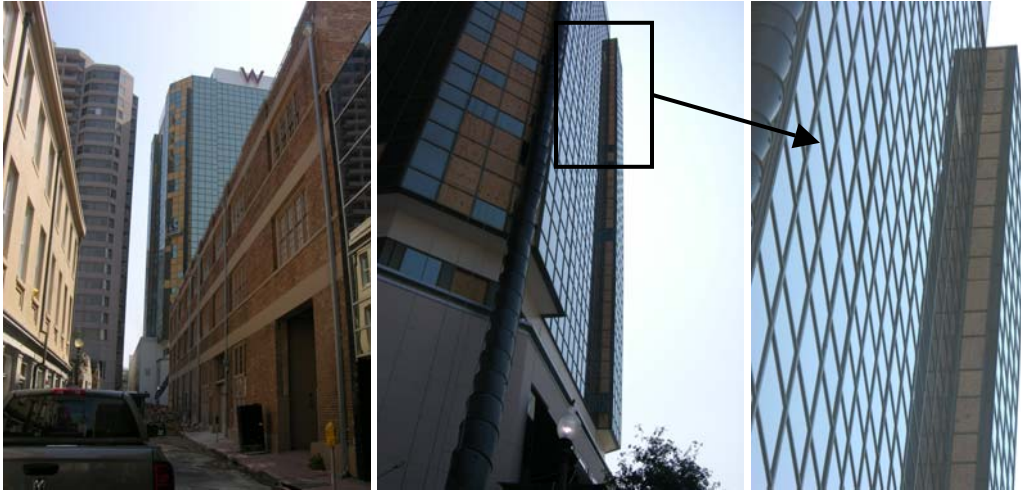
Also close to Harrah's was a hotel (Figure 10), which experienced multiple failures of the glazing. According to workers at the site, the glass lites were pulled out of the frames – there was no broken glass inside the rooms.

Figure 10 - Suction failures at nearby hotel

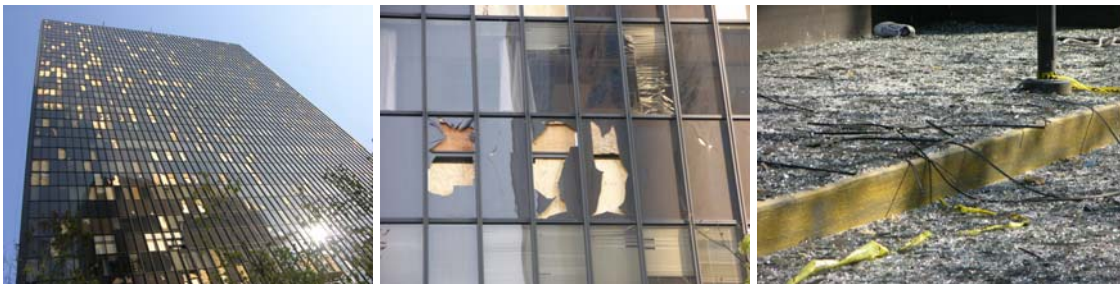
We then moved toward the area of the Hyatt hotel (a few blocks from the Superdome). Photos of this hotel were shown extensively by the media, with the concave curtainwall with most of the windows gone. Other buildings in the area also had extensive damage, including the one shown in Figure 11. The gravel found at the base among the sea of broken glass was most likely the culprit rather than wind pressure alone. Standing at the base of this building was unsettling, as falling glass was a definite threat. One worker at the site had a bandage on his neck and a blood-covered T-shirt to prove it.

Figure 11 – High-rise building on Poydras Street (near the Hyatt) – the debris at base was both broken glass and gravel

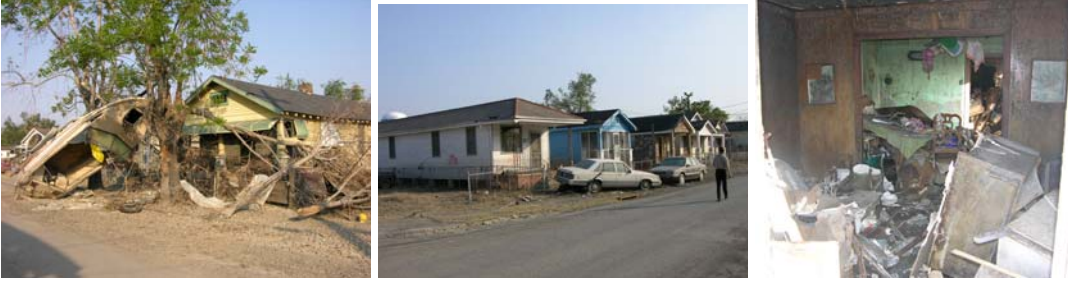
To finish the day, we headed into St. Bernard Parish (now with Elizabeth, crossing the road block was no problem) to see the damage to areas where residents were just starting to be allowed back in. Again, these were streets which were under water for considerable periods, and the interiors of the houses would need to be gutted (Figure 12).

Figure 12 - Houses in St. Bernard's Parish
